SOUND INSULATION AND ACOUSTICS IN THE BELFAST STUDIO CENTRE

Report No. B. 059

September 1954

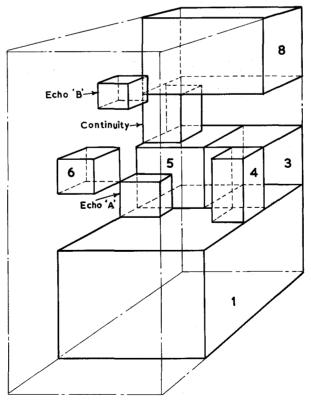
Fig.1
Layout of studios in north wing of B.H.,Beltast.
(Not to scale)

All the studios except Studio No. 2 are accommodated in one wing of the steel-framed building, as indicated in Fig. 1. It is evident from the diagram that the possibility of sound leakage exists between Studio No. 8 and Continuity Studio, Studio No. 5 and Continuity Studio, Studios Nos. 5 and 3, and between Studio No. 1 and the two drama studios Nos. 3 and 5. The effects of long-path transmissions through the steel frame have also to be considered. For example, it is found possible to hear in Studio No. 1, the sounds of an orchestra playing in Studio No. 8, sound transmission taking place through the walls or frame of the building. Impact sounds originating on the solid floor of Studio No. 1 can be heard throughout the wing.

The principal difficulties with regard to sound insulation between the studios arises from the layout of the building, all the music studios having common boundaries with studios intended for talks or drama. The possible disadvantages of the steel frame have been avoided by double-shell construction of the studios where necessary. The common boundaries could have been eliminated entirely, however, by a different layout of the available space. Interference of one programme by another can only be avoided by a complete separation of studios used for music from those used for talks or drama.

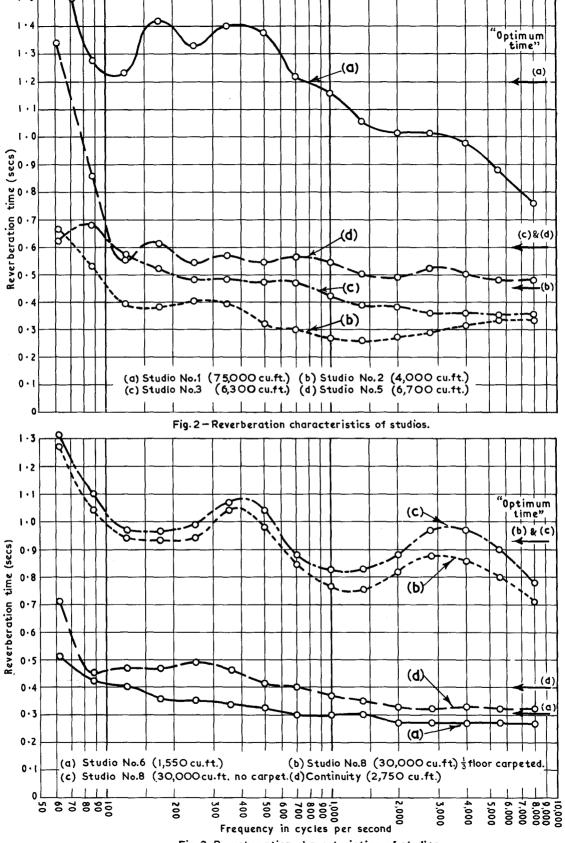
Fig. 3-Reverberation characteristics of studios.

There are colourations at 150 c/s and 430 c/s but speech quality is nevertheless fairly satisfactory. The reverberation curve is shown in Fig. 3(a). Listening tests were made more difficult by a ring in the cubicle at about 165 c/s caused by the sheet metal casing of the Marconi control desk. A ribbon microphone is used with slight bass correction to reduce the effect of excessive reverberation below 120 c/s. Sound insulation to the cubicle is just adequate and though the "howl-round" figure is not good, no trouble has been experienced.

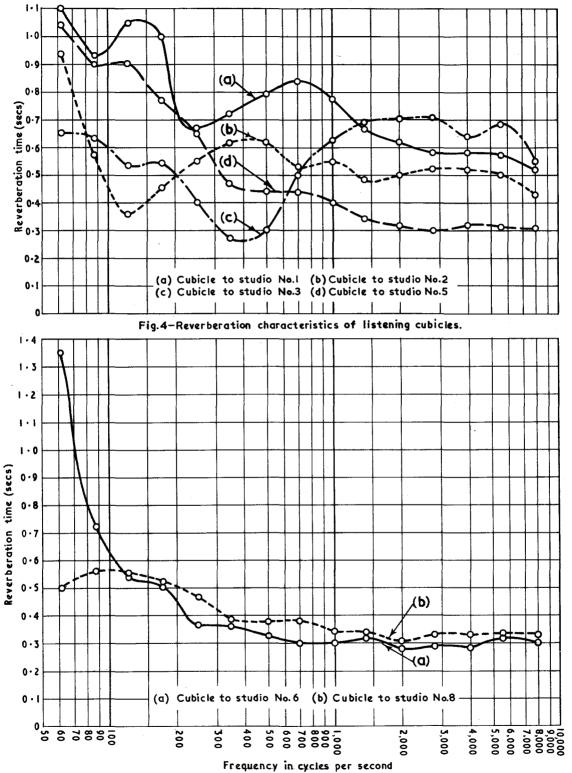
Fig. 5-Reverberation characteristics of listening cubicles.

The cubicle is boomy, the reverberation curve (Fig. 5(a)) rising steeply in the bass.

The cubicle has the same basic treatment as in 1948, but has been modified to reduce the upper frequency reverberation (Fig. 5(b)). It is considered to be satisfactory.

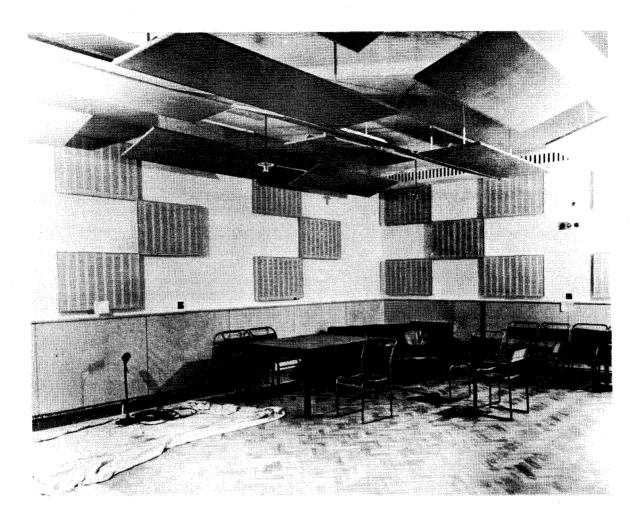
Studios Nos. 3 and 5 will be considered together since they form a pair of drama studios and the problems of their design and treatment were in many respects similar. They are rather low for their horizontal dimensions, and the original designs did not include any absorbing material on the ceilings. Experience with the studios in 1 and 1A Portland Place³ suggested that severe rings and flutters would be expected. Ceiling absorbers as used in Portland Place were therefore added, consisting of glasswool blankets enclosed in Tygan-covered frames, suspended at varying distances up to 18 in. from the ceiling. Fig. 6 which is a photograph of Studio No. 5 shows the appearance of the ceiling absorbers.

Fig. 6 - Photograph of Studio No. 5 showing absorbers suspended from ceiling to prevent flutters.

Breaking up of the ceiling areas by the use of suspended absorbing frames was successful in eliminating flutters and rings, but absorbers of a similar area forming part of the ceiling would probably have been equally effective.
